RV Inspection Report

Inspection Date / RV Model:
May 1, 2025 - 2024 Keystone Avalanche 378BH

VIN: **1YDFAVT28RE760191**

RV Care Wizard

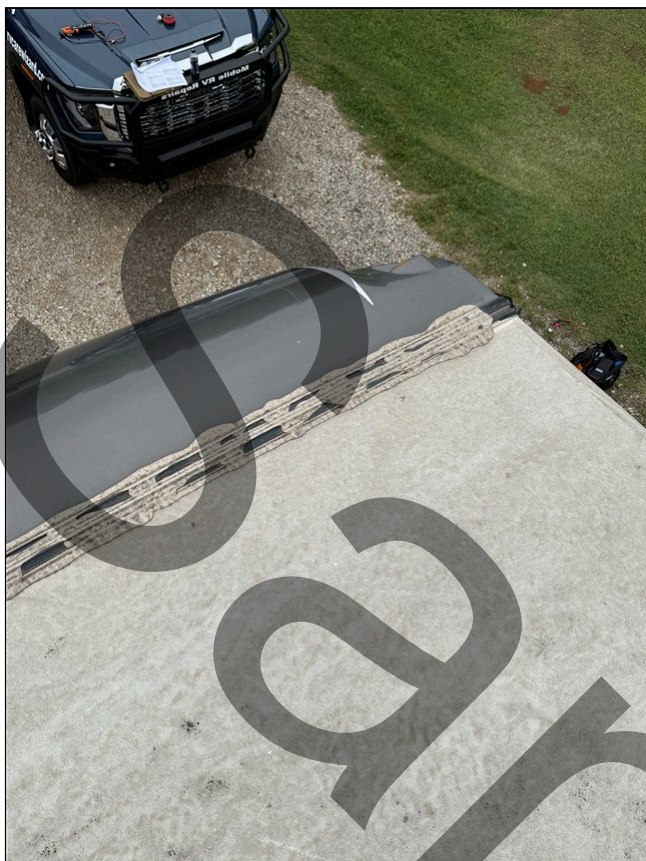
Roof Front Cap

3.1 Front Cap, Joints and Seals - Condition
Fair

The Front Cap has gaps in the Sealant. This could allow water intrusion. It is recommended this be further evaluated by a qualified RV technician

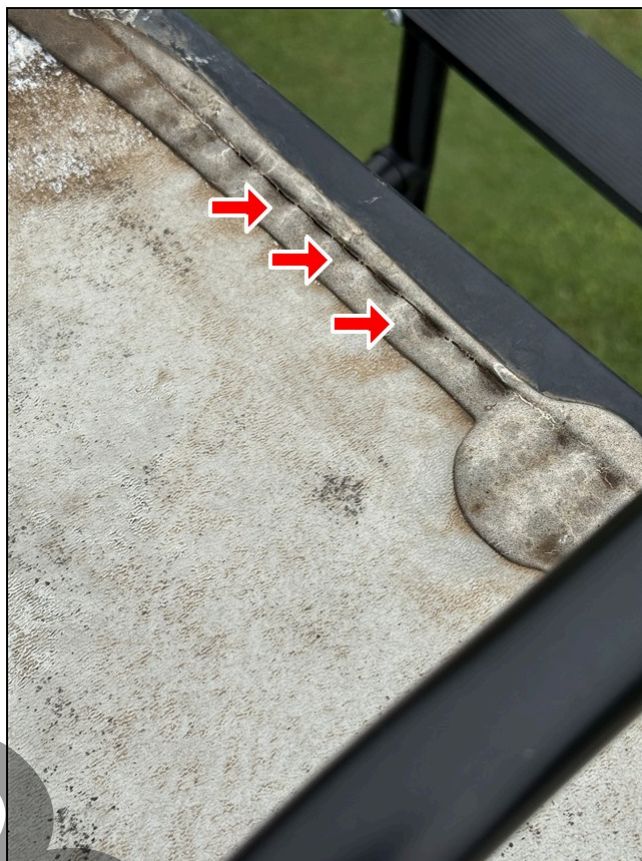
3.3 Rear Cap, Joints and Seals - Condition

The Rear Roof Seal has cracks & gaps in the Sealant. This could allow water intrusion. It is recommended this be further evaluated by a qualified RV technician

Rear Roof Cap - Left-side

Rear Roof Cap - Right Side

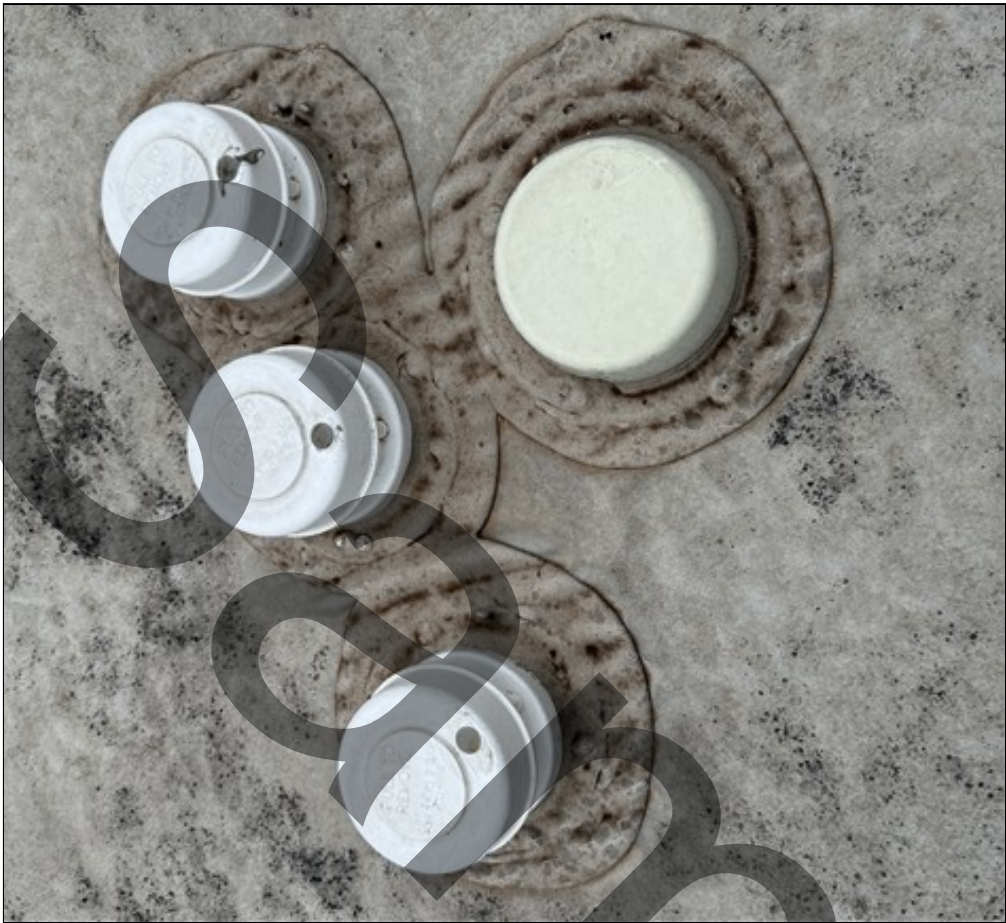
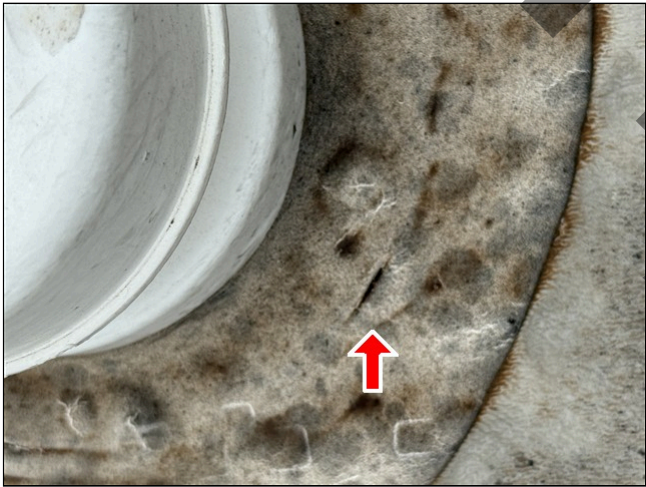
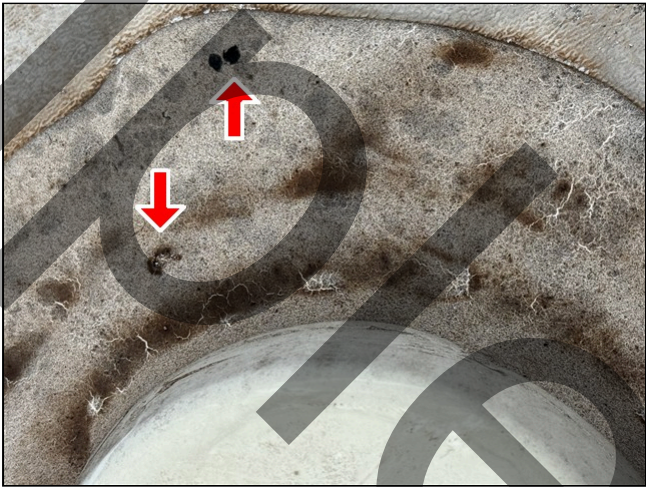
3.8 Plumbing Vent Covers - Condition

The Plumbing Vent Caps Sealant has cracks and bubbles. This could allow water intrusion. It is recommended this be further evaluated by a qualified RV technician

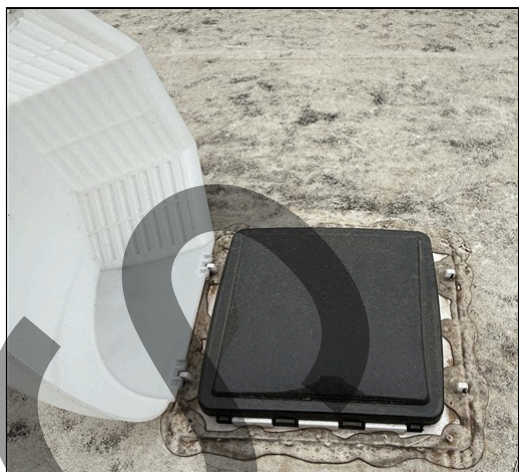
3.9 Skylights - Condition
Fair

The Skylight has cracks and gaps in the sealant around the perimeter. This could allow water intrusion. It is recommended this be further evaluated by a qualified RV technician

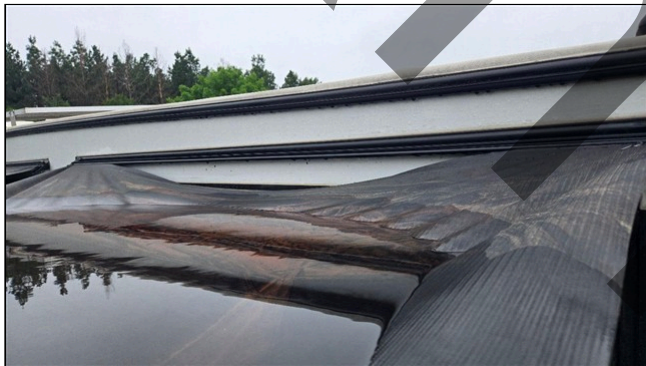
Streetside Rear Slide-out Topper

The slide-out topper operated properly. The slide-out topper fabric was pulled away from the center of the slide-out topper. The material was holding water, It is recommended this be further evaluated by a certified RV Technician.

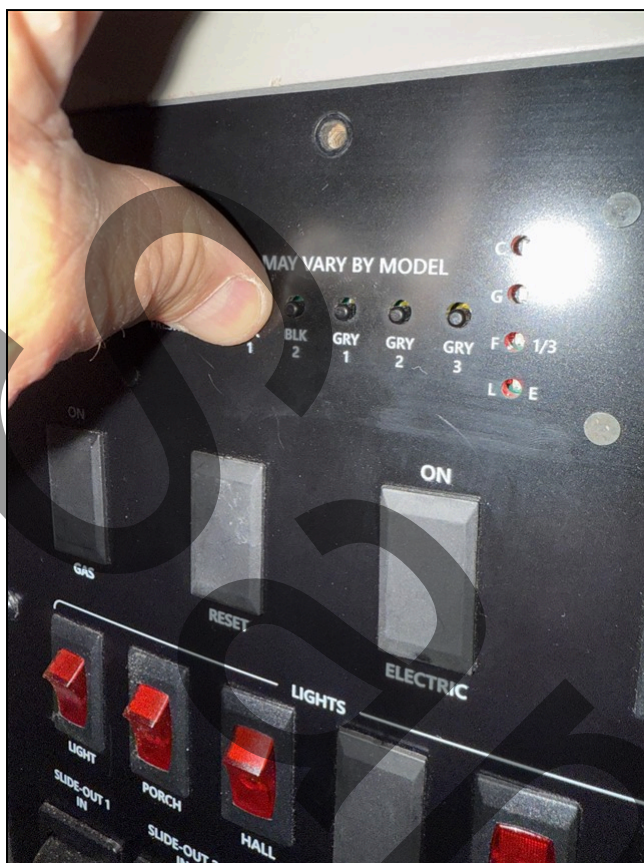
Waste Tank Indicator Lights

20.36 Battery / Waste / Water Monitor Panel - Condition

The Waste water indicator lights do not show correct amounts on the indicator lights. It is recommended this be further evaluated by a certified RV Technician.

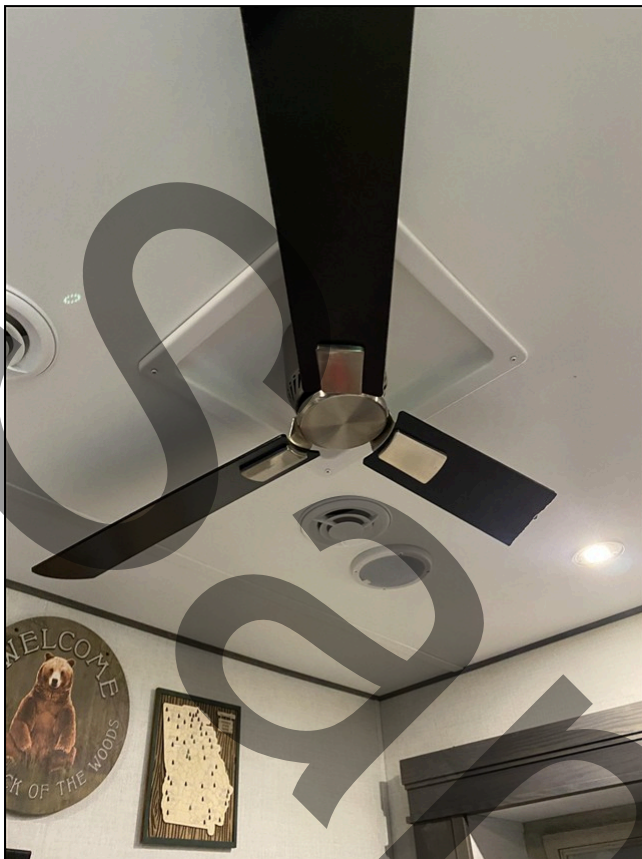
Living Room Ceiling Fan

The living room ceiling fan has a broken blade. It is recommended this be further evaluated by a certified RV Technician.

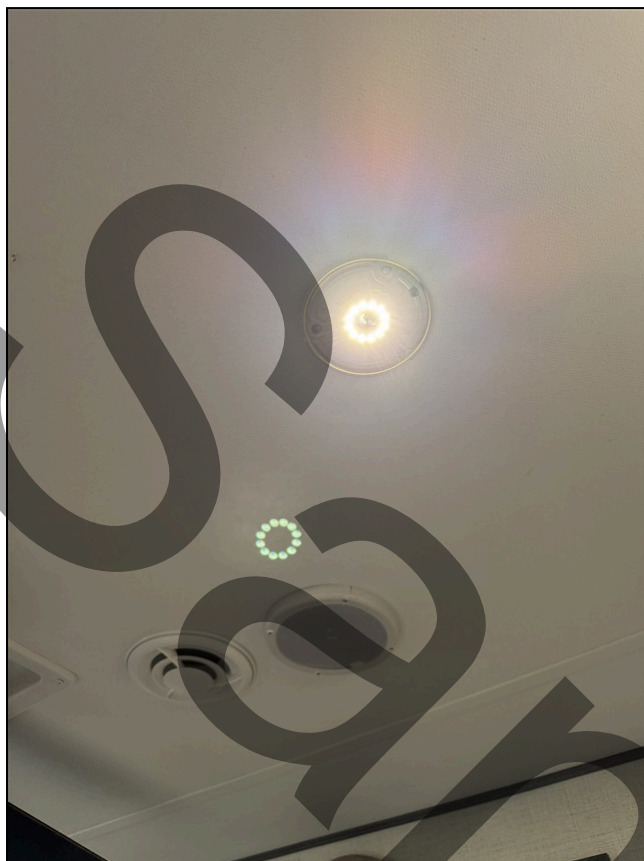
Living Room Ceiling Light Fixture

21.11 Lights and Light Fixtures - Condition

One of the ceiling lights is missing a cover. It is recommended this be further evaluated by a certified RV Technician.

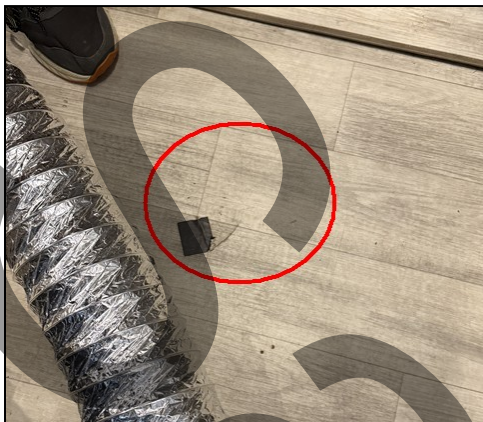
Vinyl Floor in front of Refrigerator

(1) The vinyl flooring in front of the refrigerator has a torn place in the floor. It is recommended this be further evaluated by a certified RV Technician.

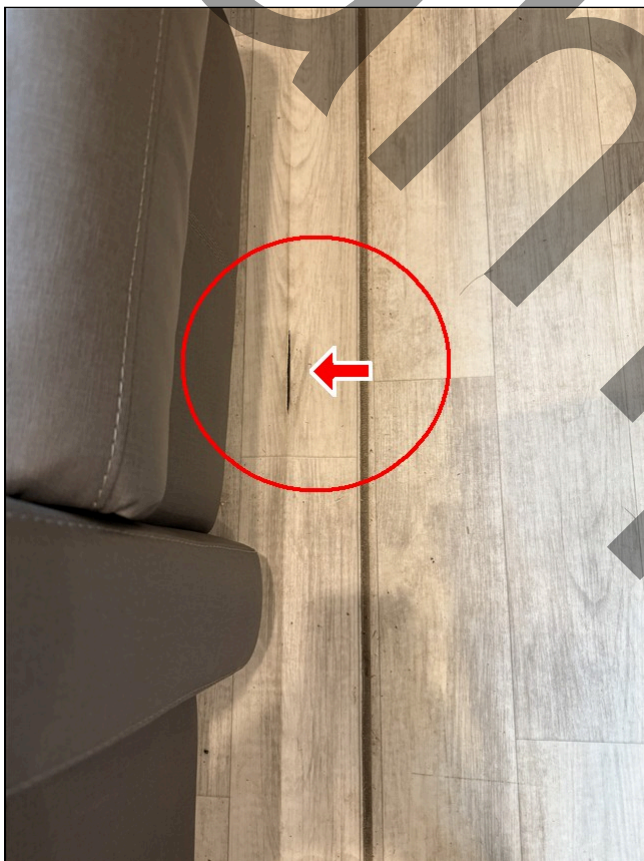
Vinyl Floor in front of the recliner

(2) The vinyl flooring in front of the recliner has a torn place in the floor. It is recommended this be further evaluated by a certified RV Technician.

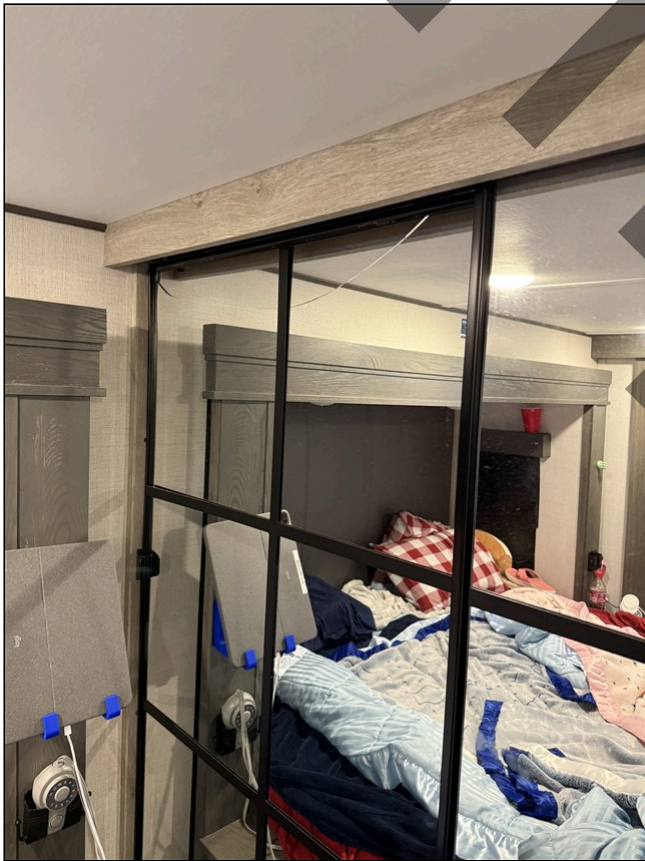
Master Bedroom Closet Door

22.7 Closets Doors / Cabinets Door / Drawers - Pull-Out - Condition

The closet door has a broken section of the mirror. It is recommended this be further evaluated by a certified RV Technician.
